## **2275 Quadra Street, Victoria**

### **Demolition Impact Assessment & Construction Impact Assessment**

DATE OF ORIGINAL ISSUANCE: March 20, 2024 (updated Oct. 7  
and Nov. 29, 2024)

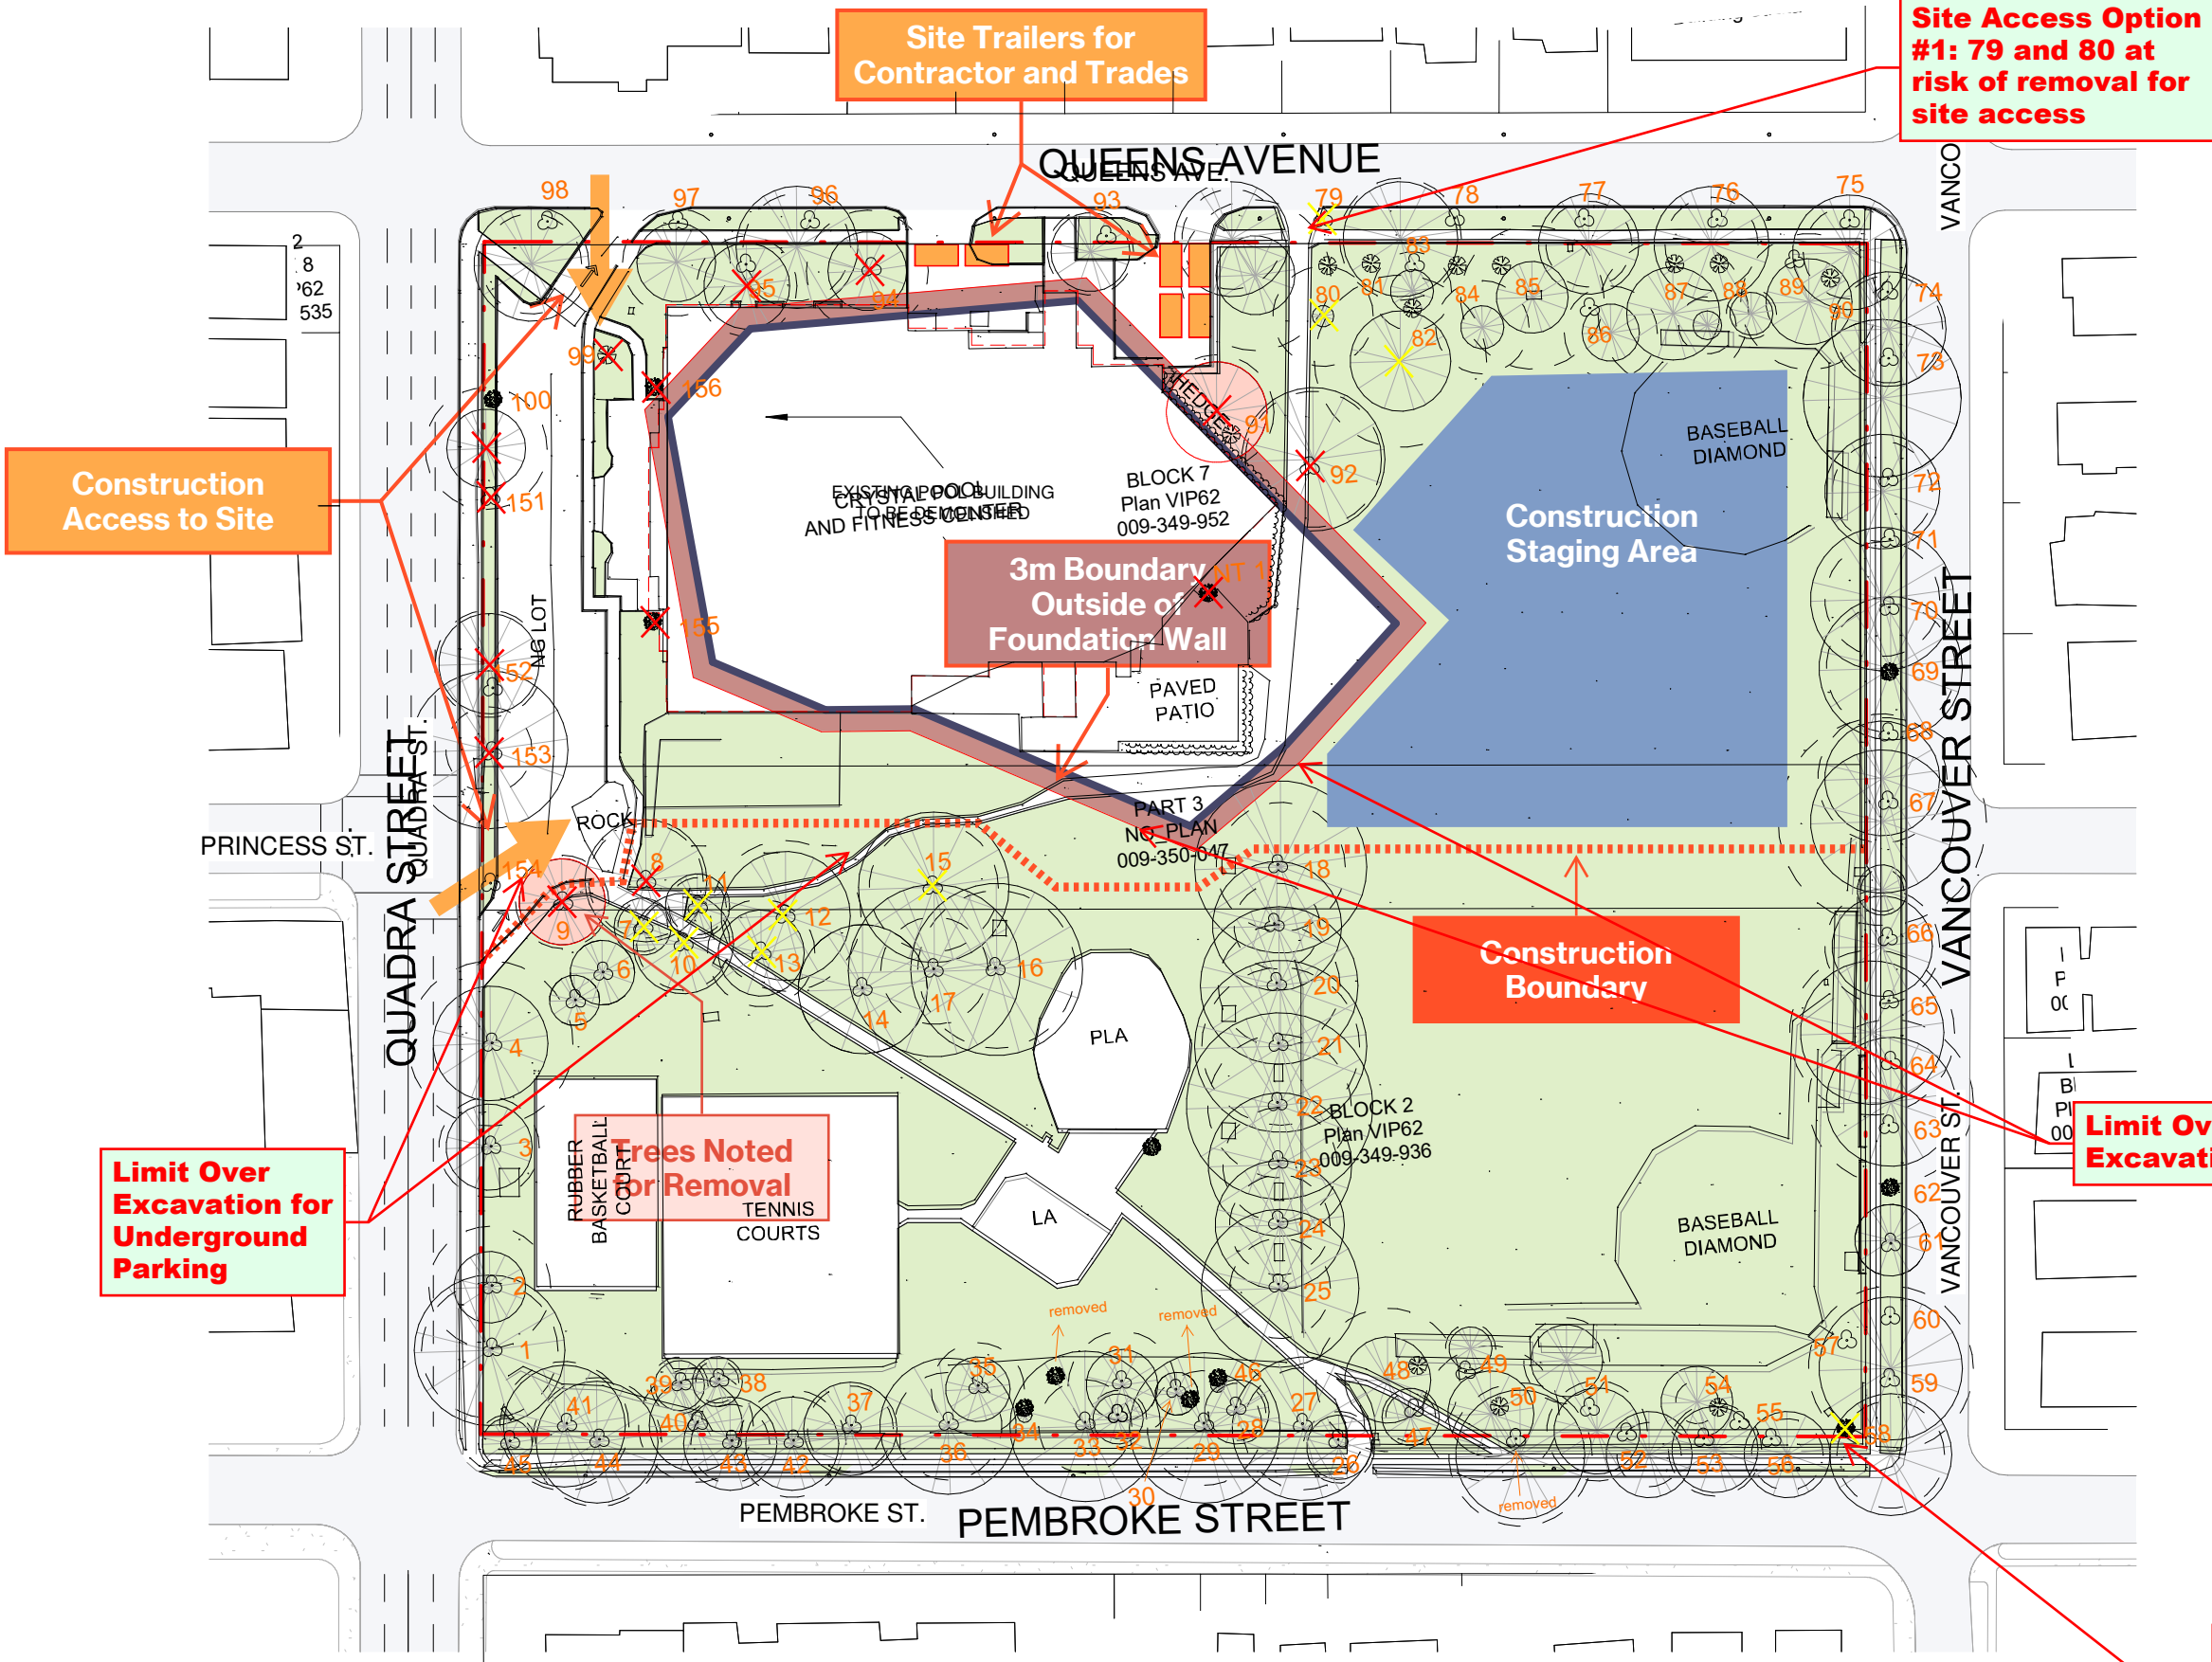
**Site Access Option #2:  
Removal of tree 58  
required, clearance  
pruning for tree 59 56  
and 55 required**

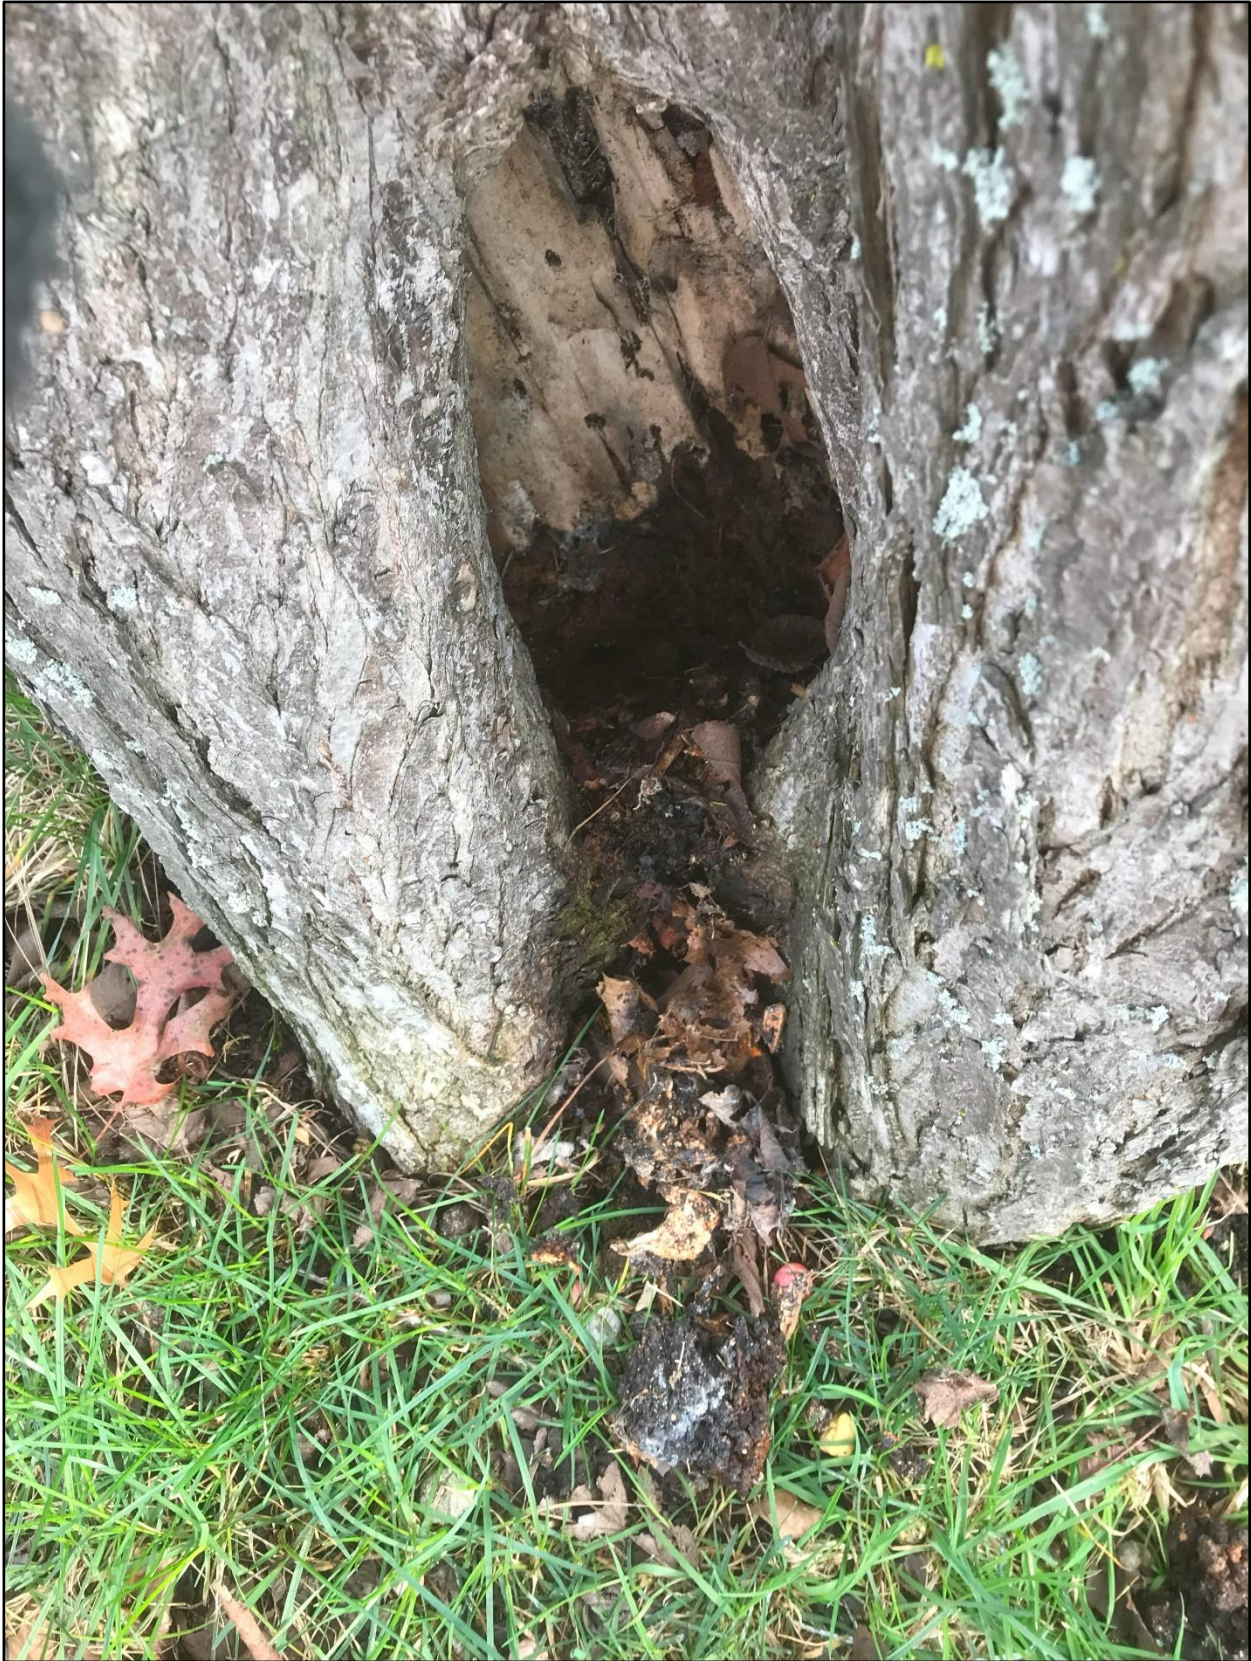
Photo 2: Cavity at the base of tree #9

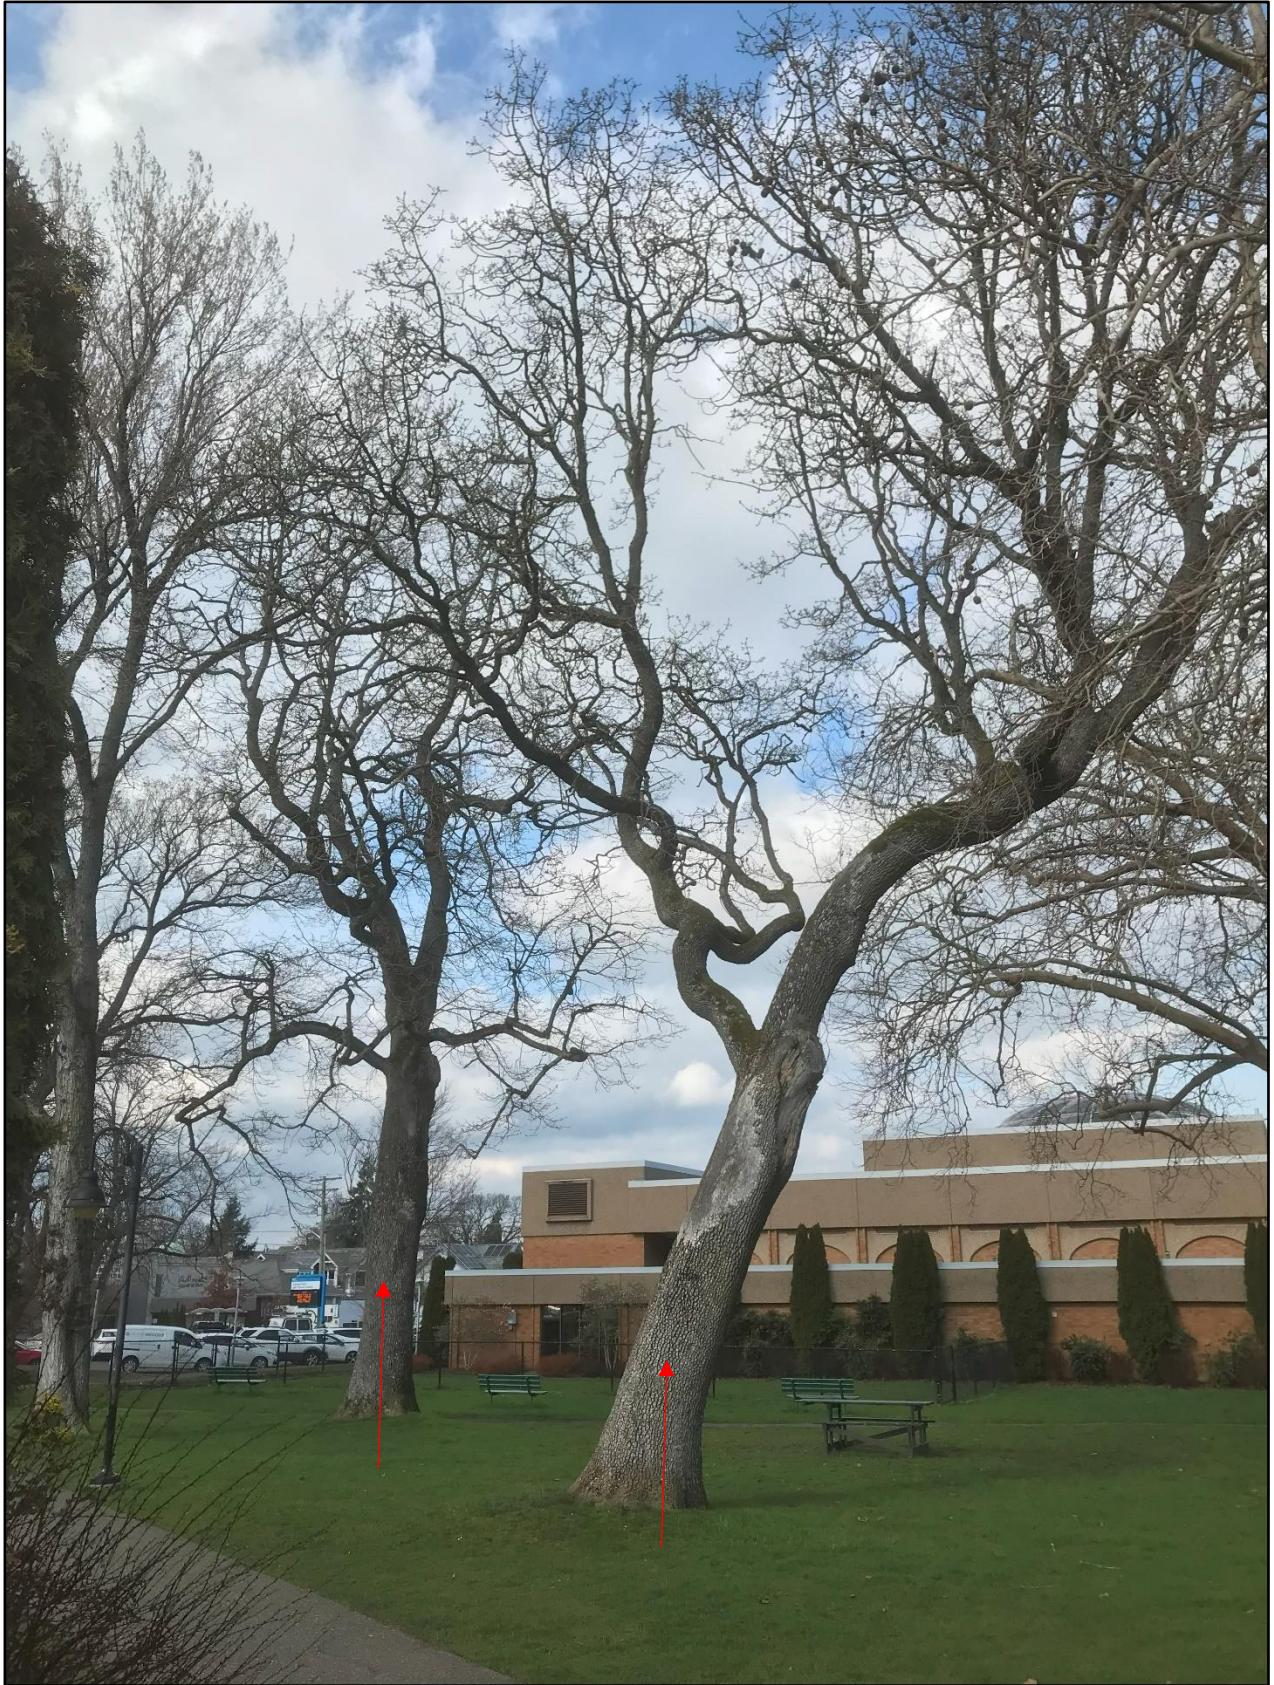
12	City	Garry Oak	<i>Quercus garryana</i>	108	18	11	Fair	Fair	Good	3 large (40cm+ diameter) pruning wounds with decay on main trunk. Leaning north.	Conditional	At Risk	Conditional	At Risk
13	City	Field Elm	<i>Ulmus minor</i>	79	12	8	Fair	Fair	Good		Conditional	At Risk	Conditional	At Risk
14	City	Garry Oak	<i>Quercus garryana</i>	94	18	9.5	Fair	Fair	Good	80cm by 40cm tearout wound on main trunk. Leaning. Bark flaking opposite lean	Conditional	At Risk	Suitable	Retain
15	City	London Plane	<i>Platanus x acerifolia</i>	92	21	9	Good	Fair	Good	End-weight reduction pruning historically.	Conditional	At Risk	Conditional	At Risk
16	City	London Plane	<i>Platanus x acerifolia</i>	113	27	11.5	Good	Fair	Good	Surface roots, end-weight reduction pruning historically.	Unsuitable	Remove	Suitable	Retain
17	City	London Plane	<i>Platanus x acerifolia</i>	76	24	7.5	Good	Fair	Good	End-weighted limb south side, decay in wound on southeast limb.	Unsuitable	Remove	Suitable	Retain

Photo 3: Tree #12 (left) and tree #14 (right)

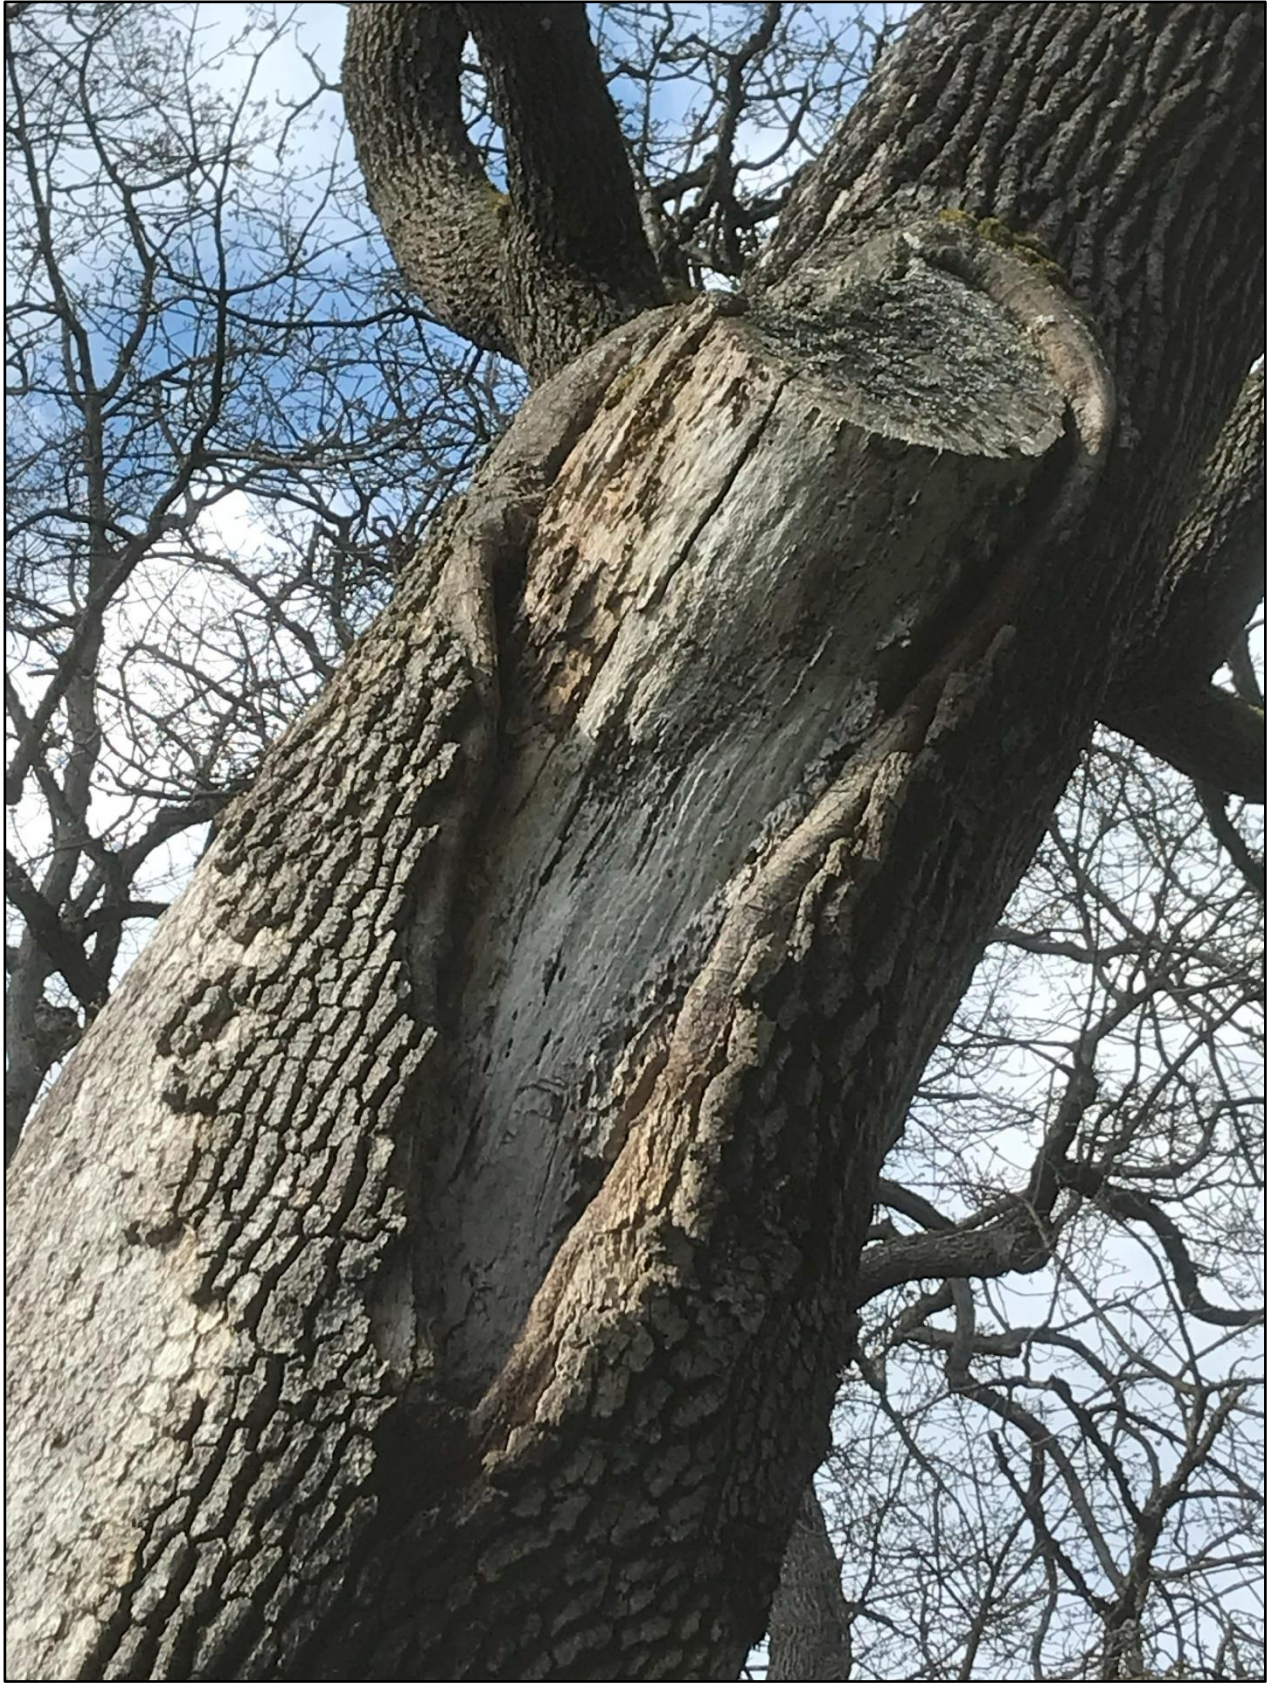
Photo 4: Large wound on tree #14

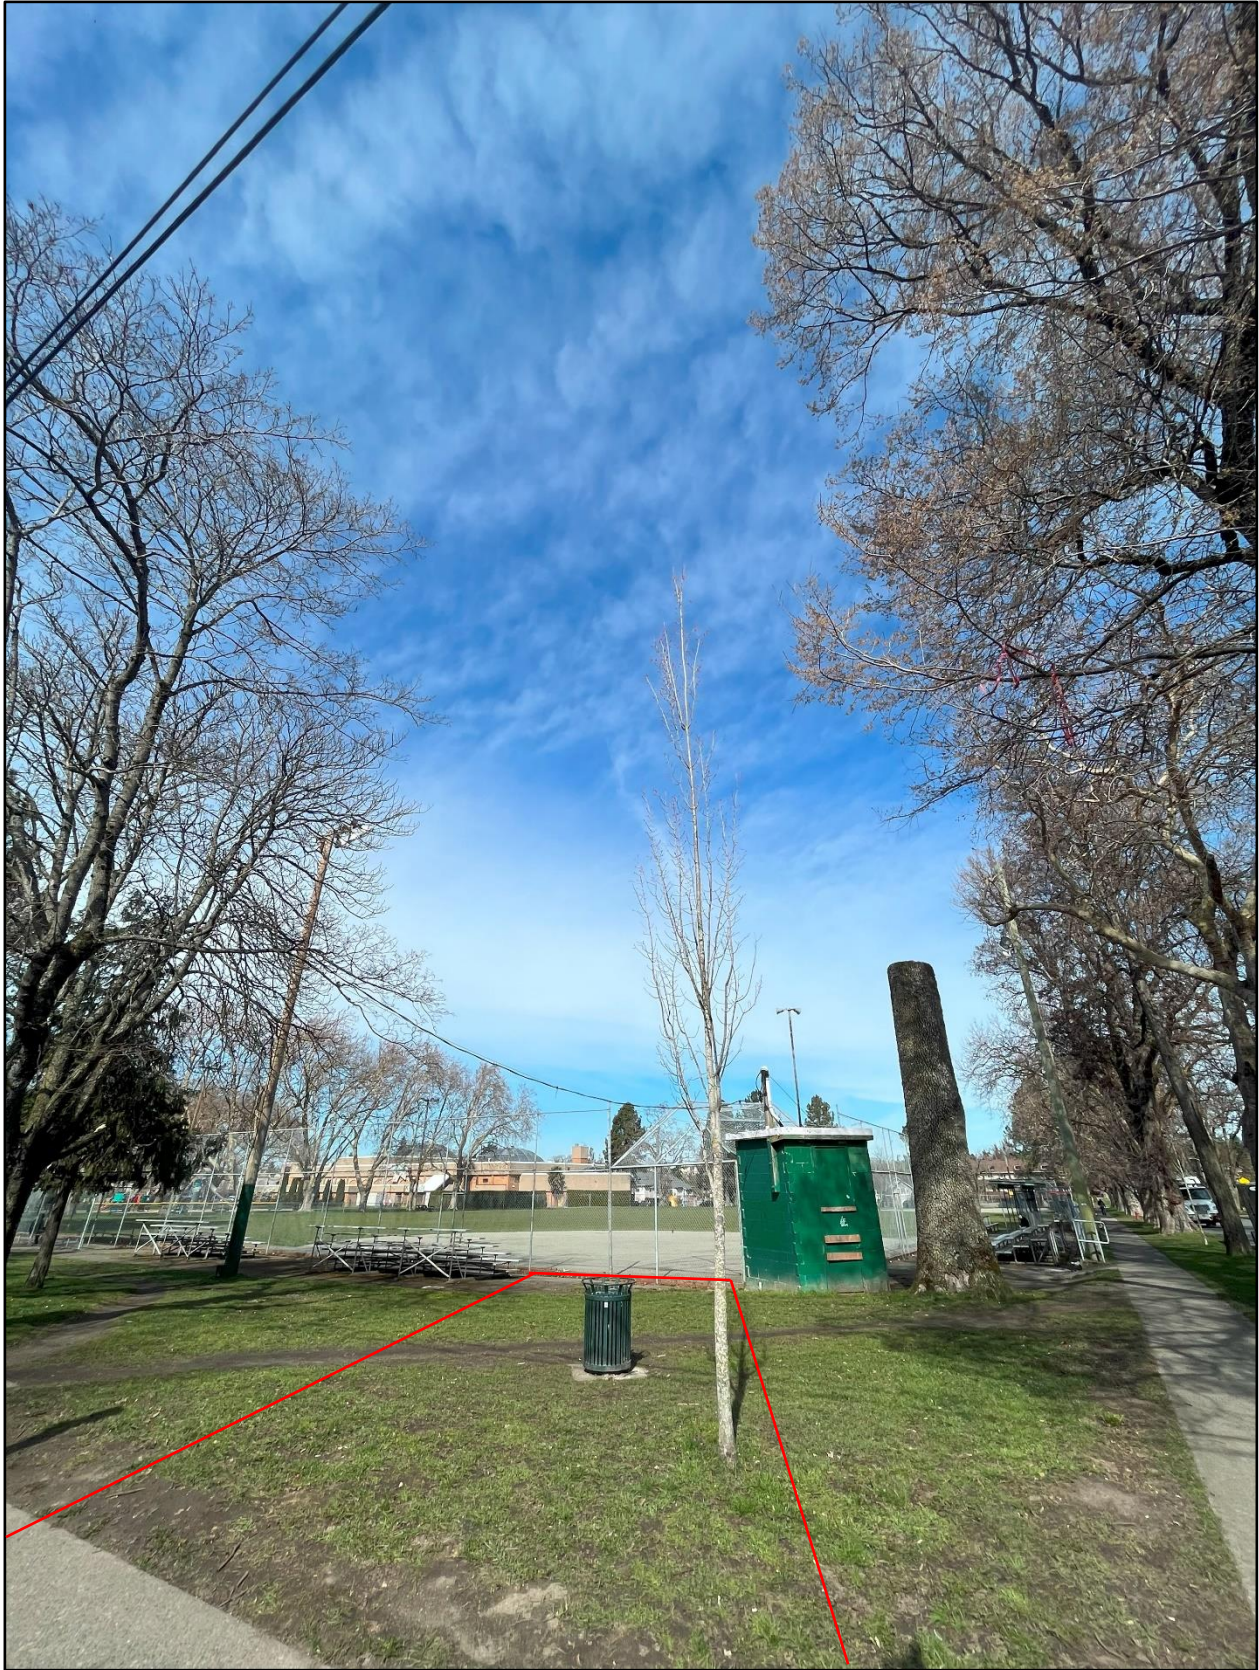
Photo 6: Site access to staging area (outlined in red) for Option #1 and Option #3. Potential site access for Option #2. Required removal of tree #58 and some clearance pruning of trees #55, #56, and #59

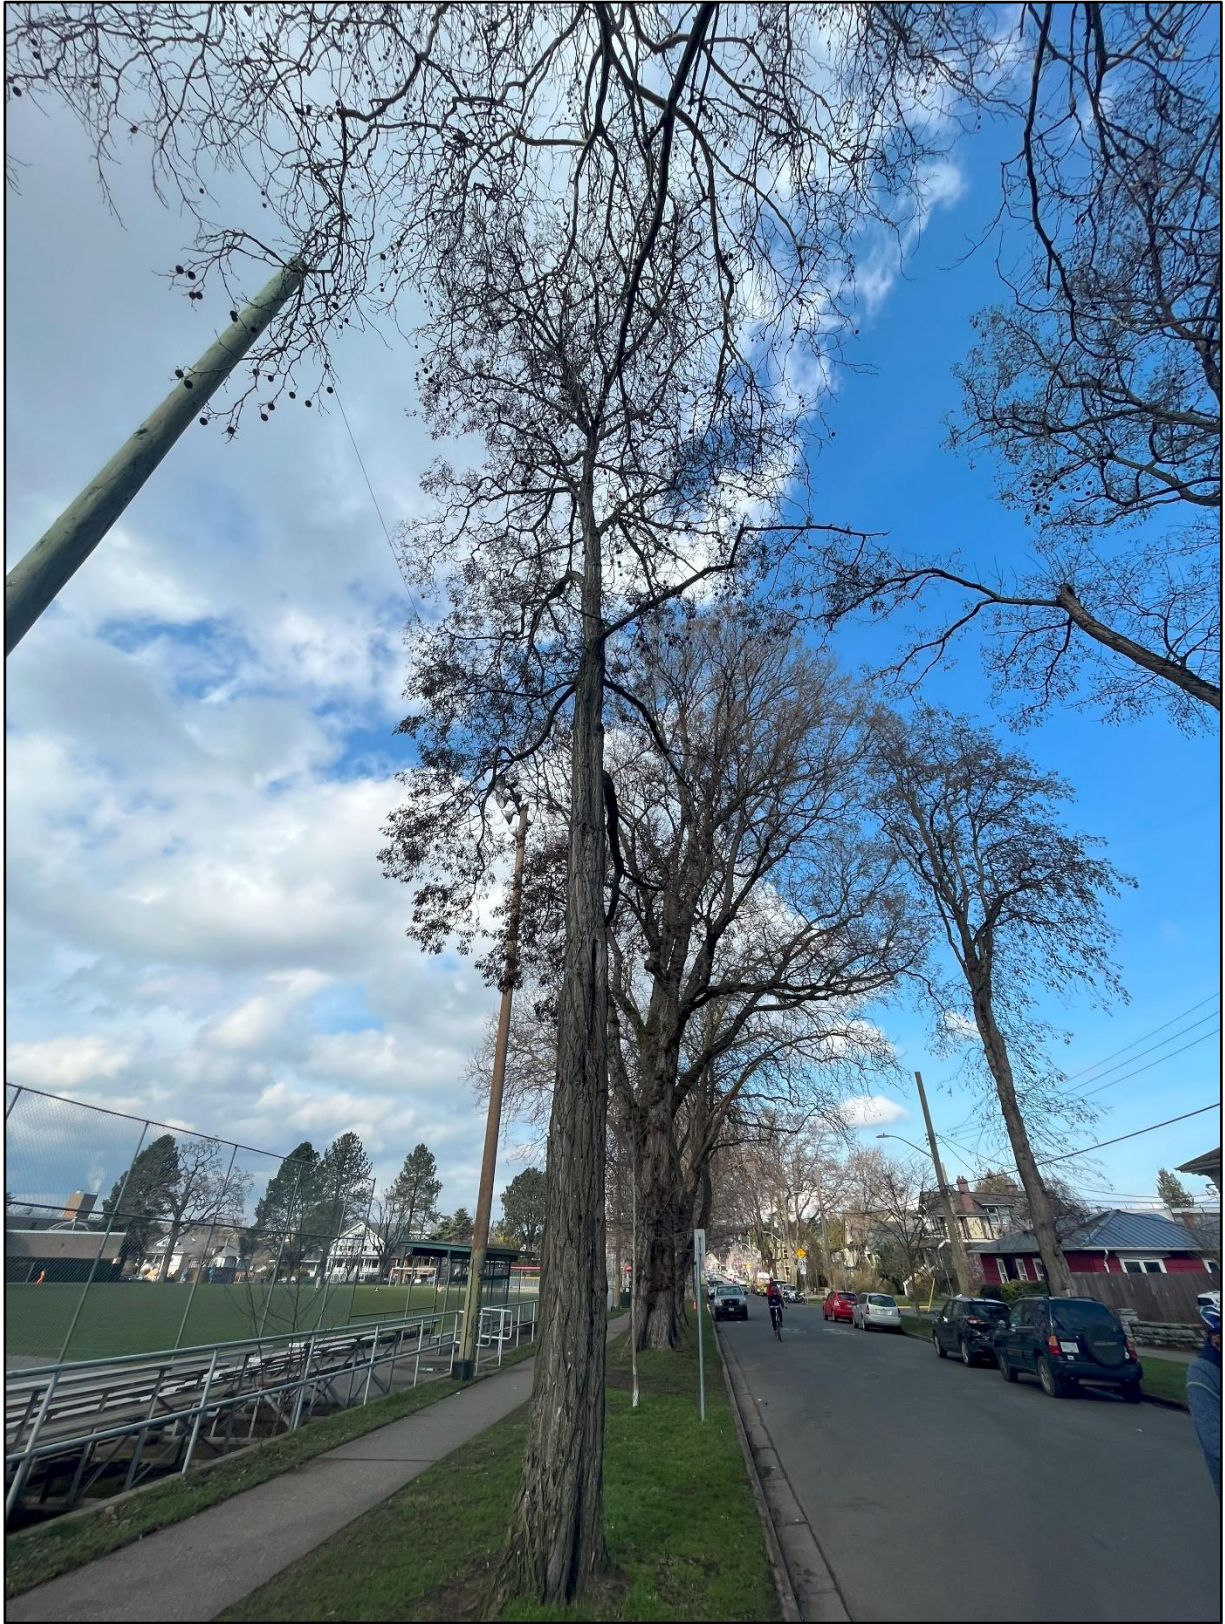
Photo 7: Tree #61 with cavity

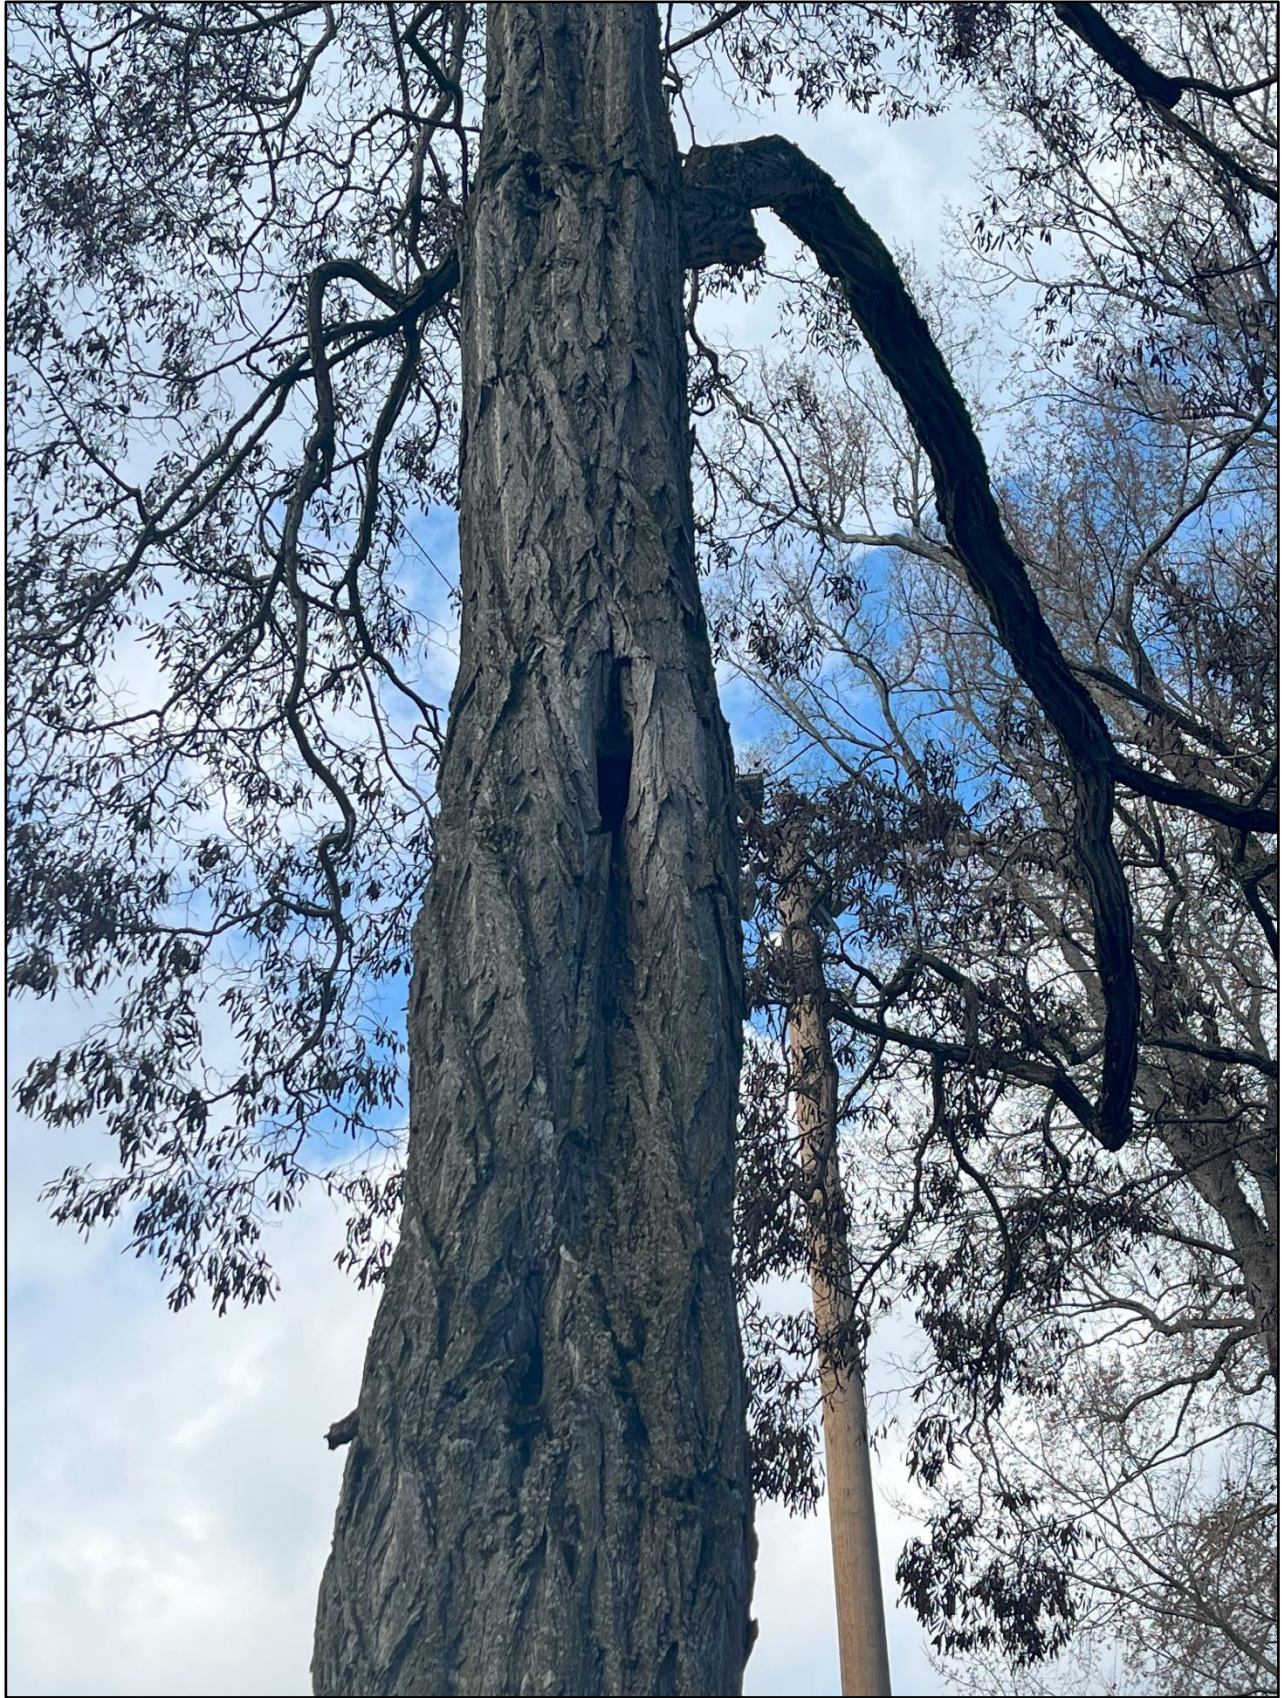
Photo 8: Close-up of cavity within tree #61

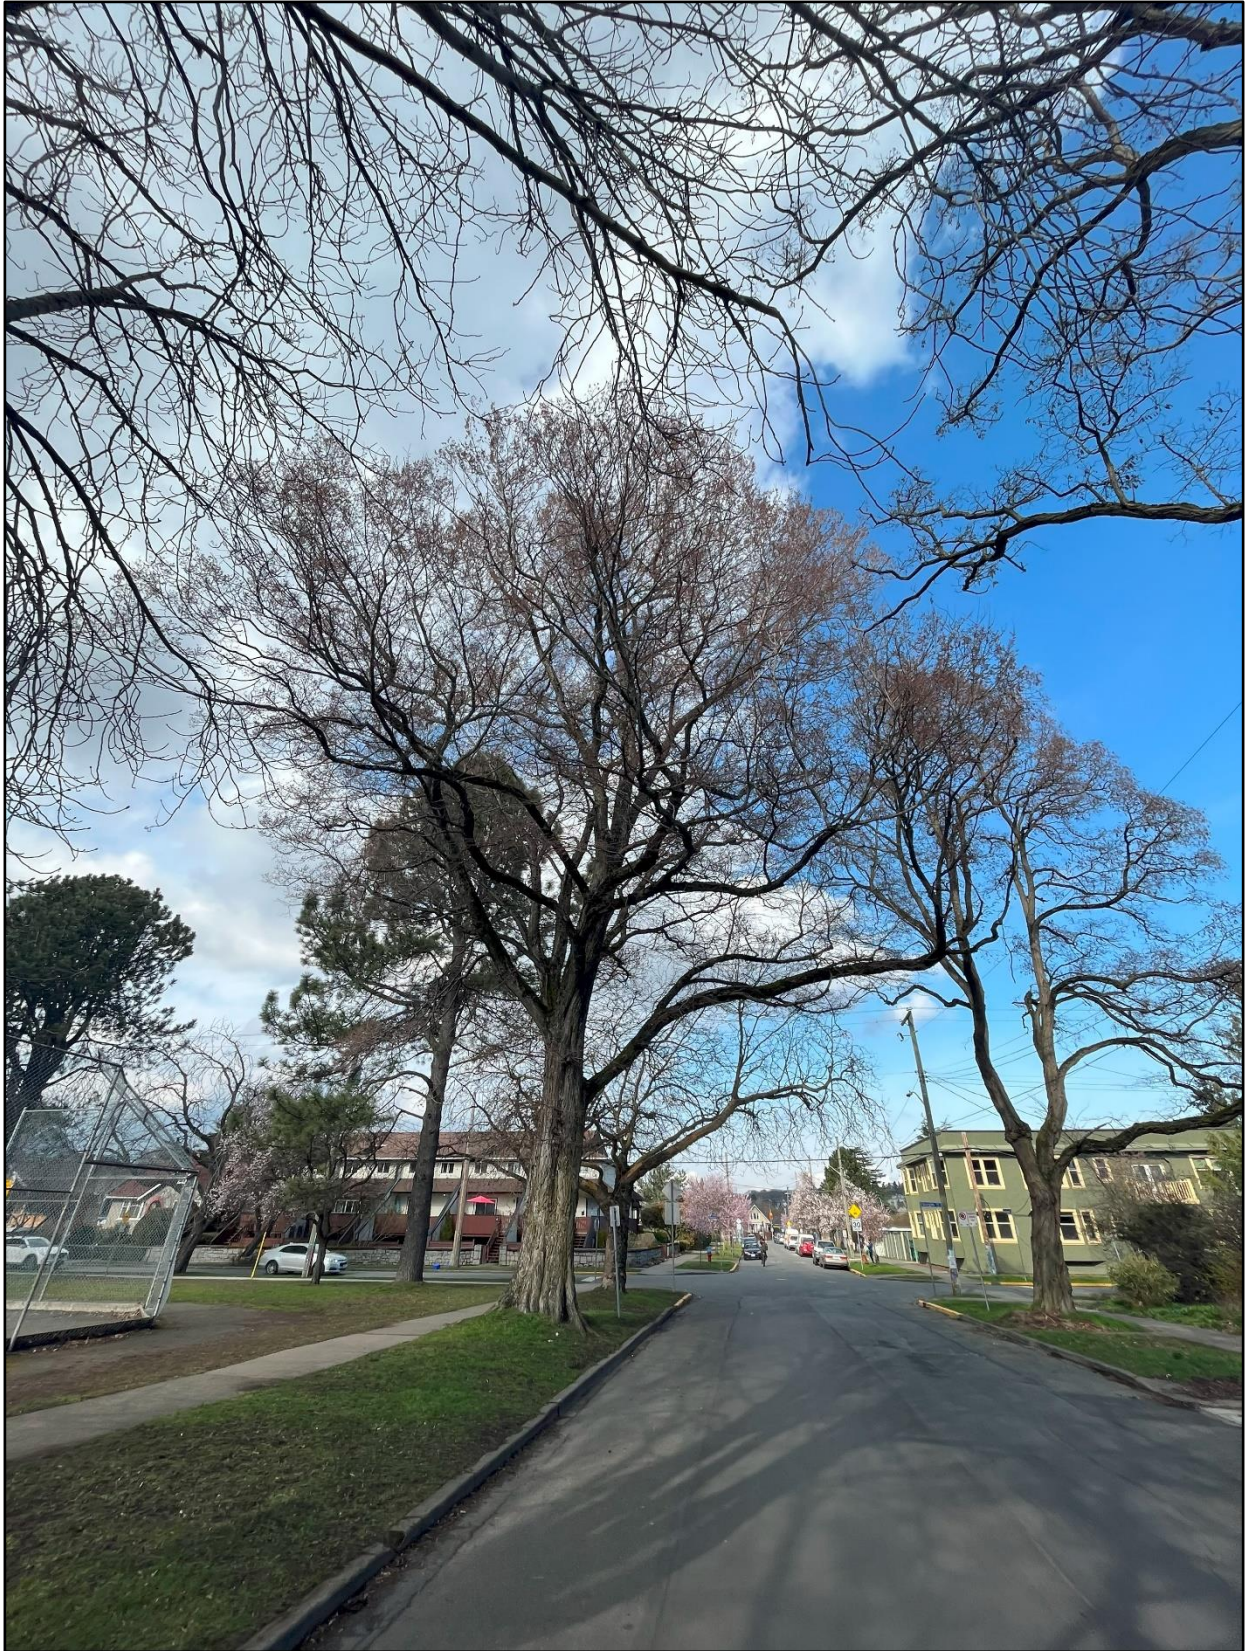
Photo 10: Tree #73 with extended limb over Vancouver Street

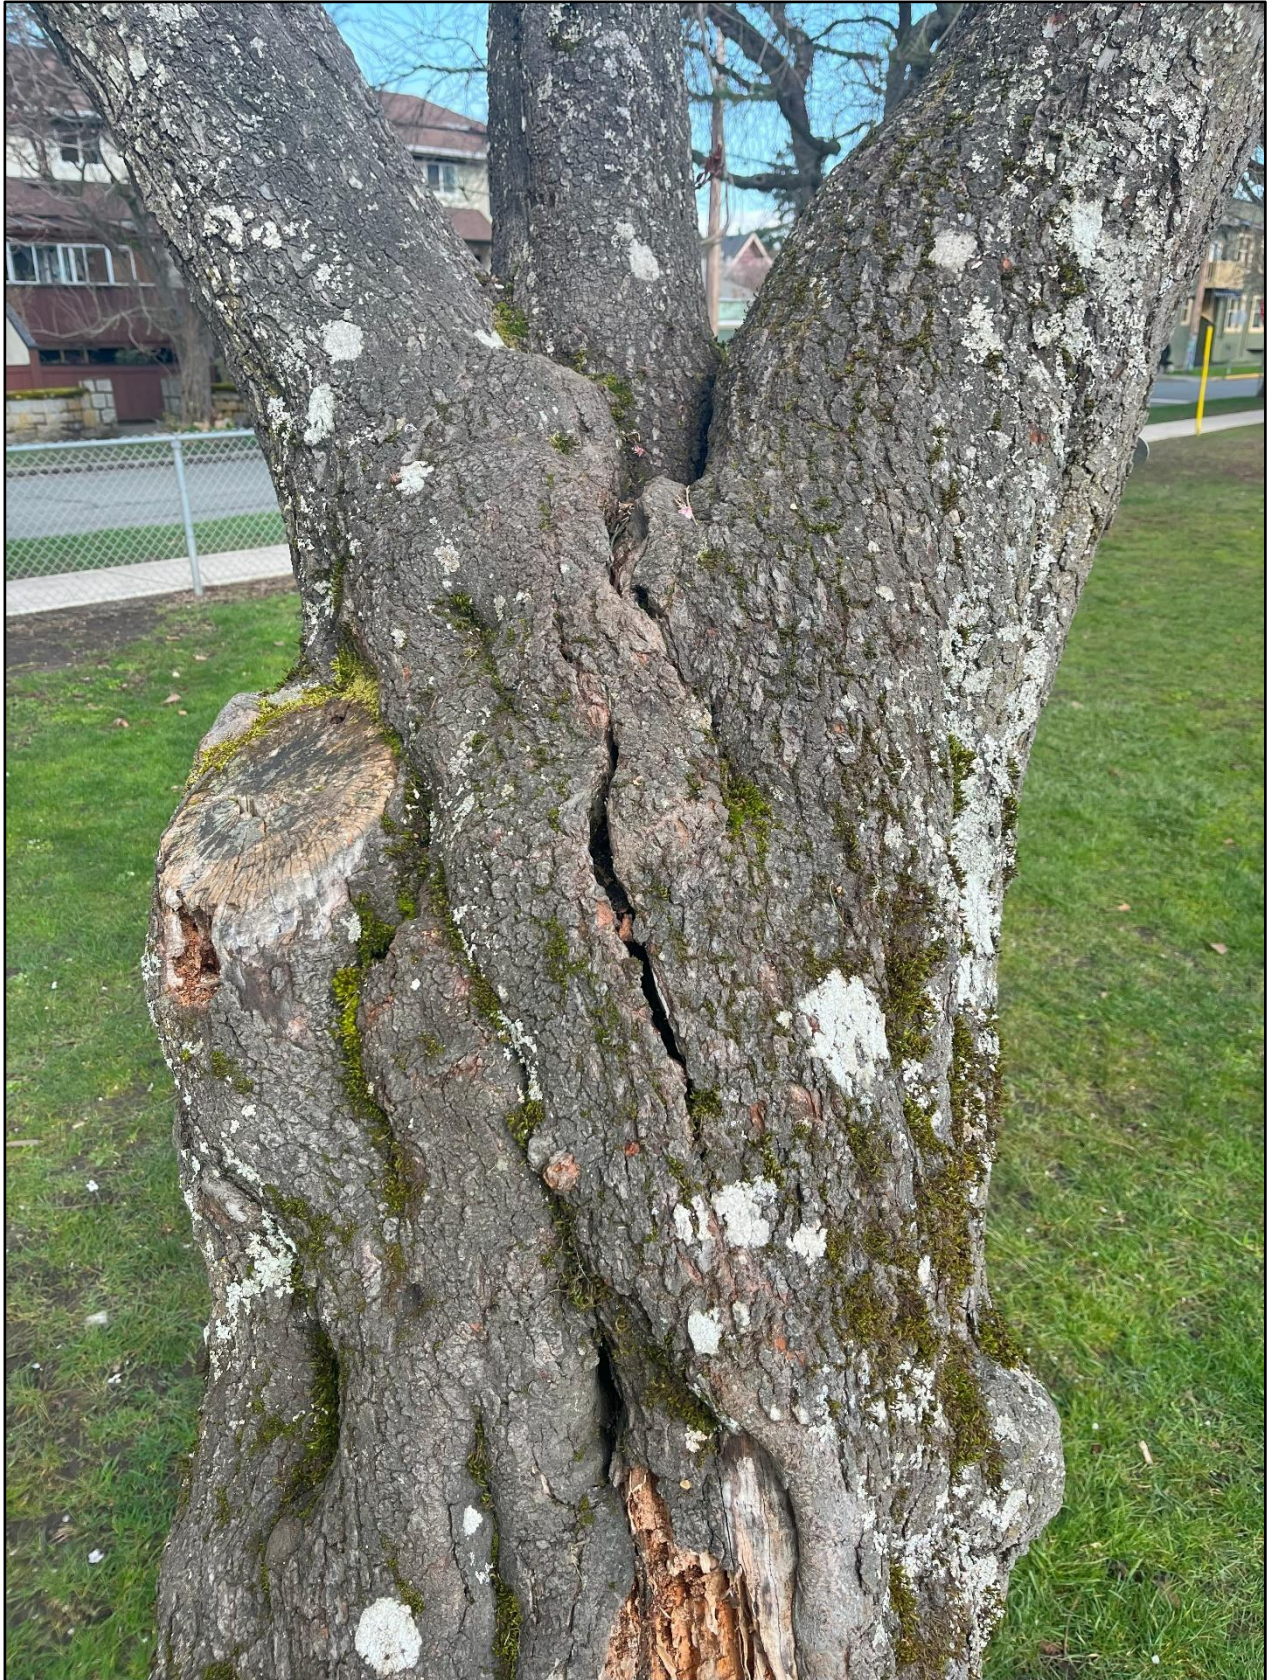
Photo 14: Crack along trunk of tree #86

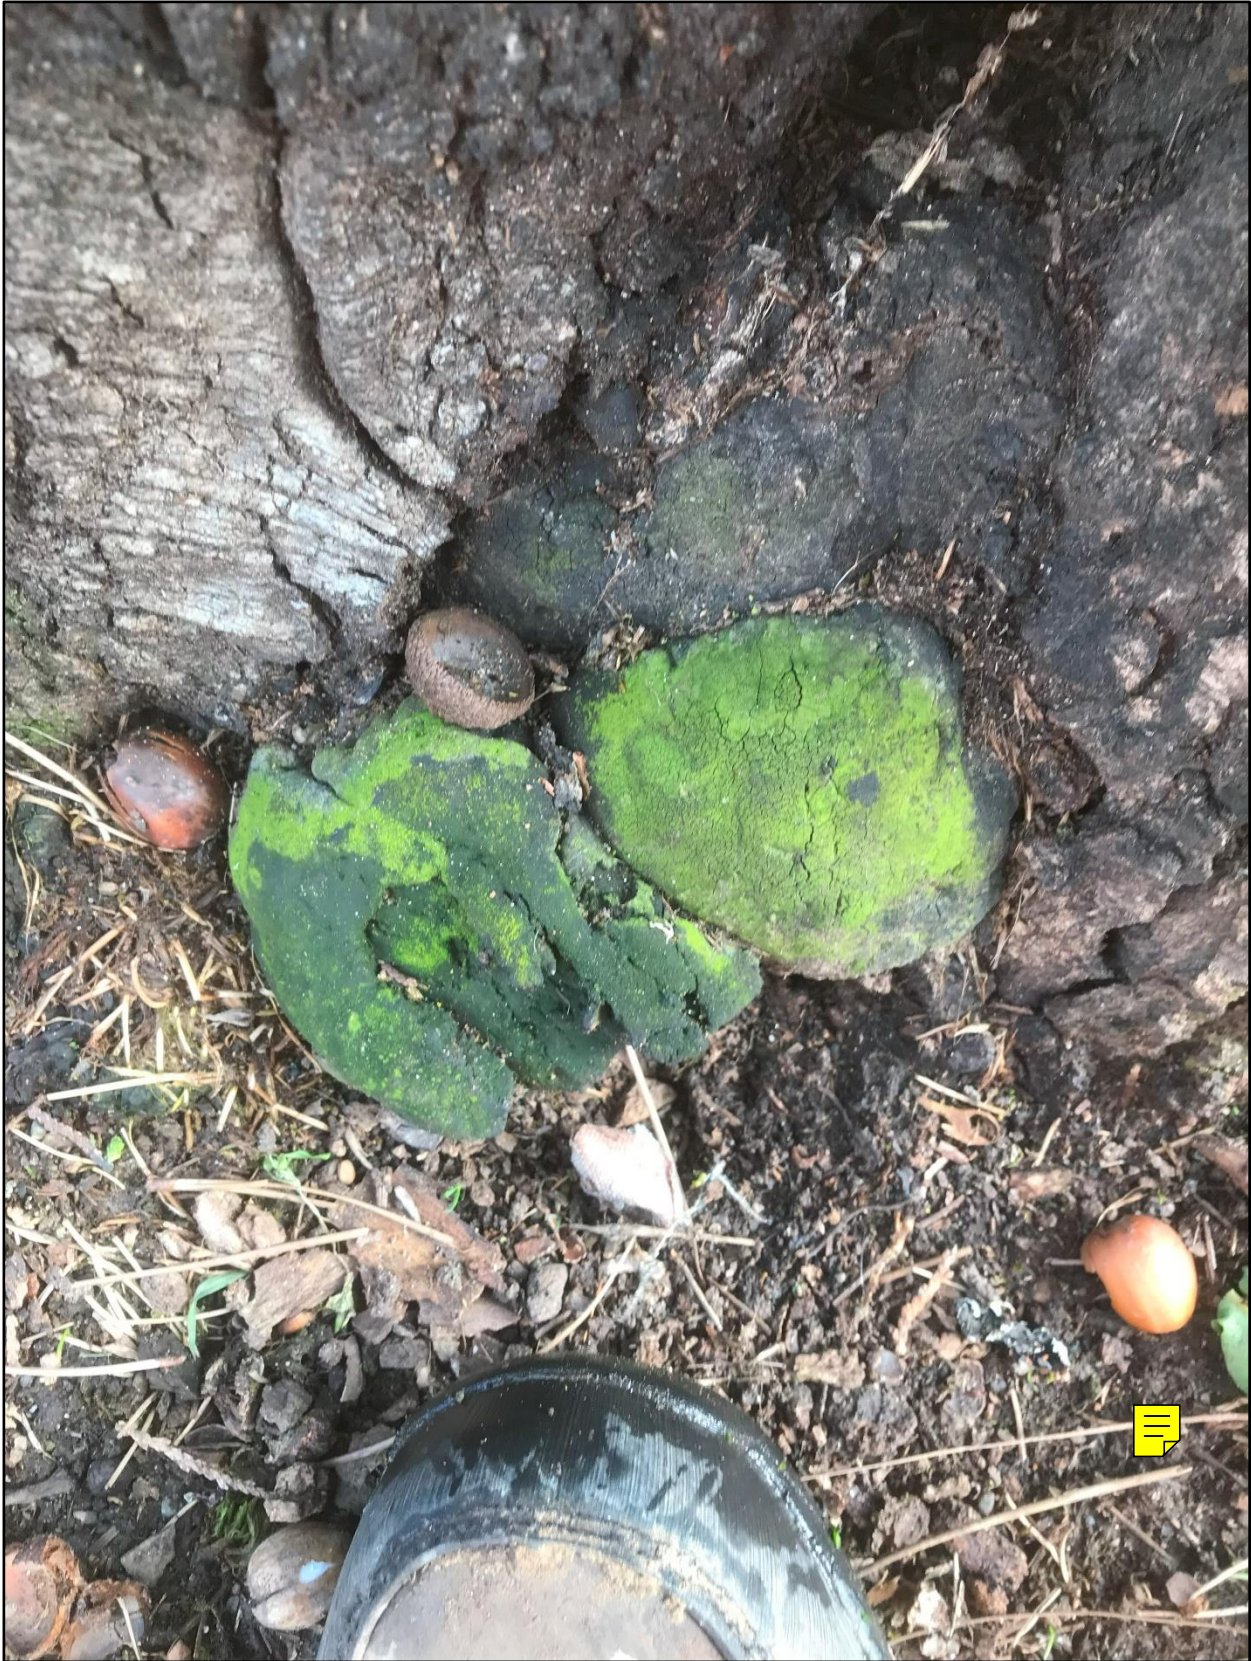
Photo 16: Ganoderma fruiting body found at the base of tree #92
