Crystal Pool and Wellness Centre - Preliminary Arborist Report

Compiled by Gregg Staniforth
City of Victoria Parks
June 29, 2017

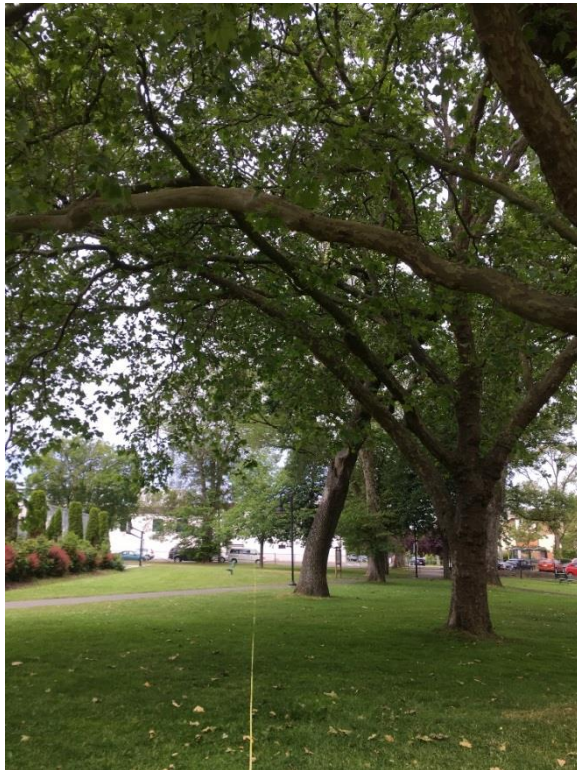
Figure 2. Version A – proposed northern building footprint

This version will ultimately have more of an impact on the North side of the proposed site. Trees #5, #6, #14, #16 and #17 will need to be removed and trees #9, #10 and #13 will require further assessment. Exploratory excavation is recommended for tree #10 and tree #13 to determine the impacts to roots. Advanced risk assessment is recommended for tree #9 which has a deep cavity at the base. Elms are located on the Quadra frontage and this species can have an extensive root system, so exploratory excavation is recommended for tree #3 and tree #4 to determine the potential impacts to the root systems. This will ultimately determine whether alternative construction measures are required when working around these trees. Tree #1 could arguably be a centerpiece tree located at the front entrance. Careful examination of root architecture and mitigation

measures will be required such as the use of floating pavers when working around this tree. In addition, risk assessment including an aerial inspection is strongly recommended for tree #1 to evaluate any defects that may not be seen from the ground. Tree assessments with respect to retention/removal are summarized in Appendix B, Version A.

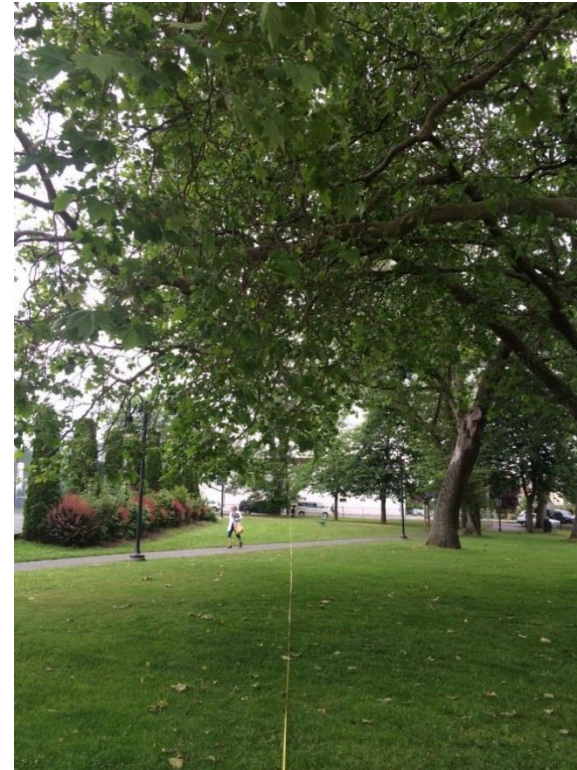
Figure 3. Version B – proposed northern building footprint

This version is longer with less of a western setback and will further encroach on the critical root zones of trees #1, #3 and #4 along the Quadra frontage. As in Version A, exploratory excavation is recommended for these trees. The use of alternative excavation will likely be required and extensive pruning of tree 1 will be necessary to provide clearance for the building and work zone. On the North side of the site, trees #5, #14, #16 and #17 will potentially need to be removed. Risk assessment of tree #9 is recommended as in Version A. The main difference between this version and Version A along the North side, is the retention of tree #6 and exploratory work is not required. Figure 2 and 3 show the approximate location of the building footprint on the northern side of the site illustrated by the yellow measuring tape. Tree assessments with respect to retention/removal are summarized in Appendix B, Version B.
